Documentation/ Work Order Mechanical

10256-4 Current Prob No: Mechanical/4

Location/Equipment Information	
Asset ID:	
Barcode:	
Location:	PULP MILL BOTTOM FLOOR UNDER REFINERS AGITATOR NO2 LATENCY CHEST B (PEM 877)
Problem:	high temperature on casing on motor

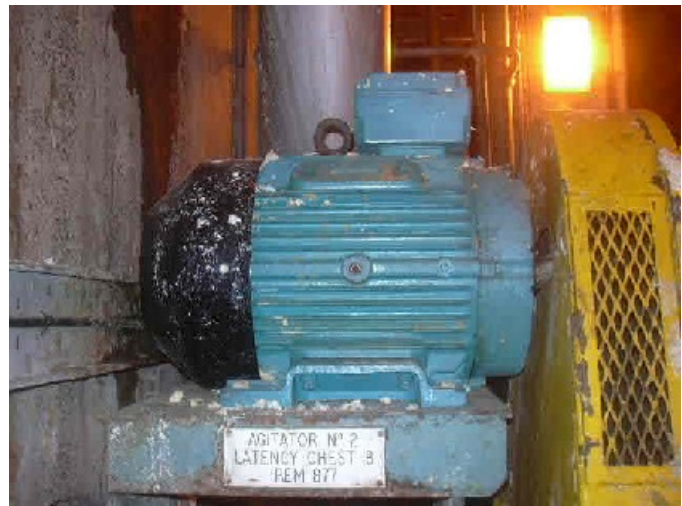
IR File: E0825-57.BMP

Operation Priority:	Critical to operation		
Repair Priority:	1-Critical		
Ambient:	32 C	Environment:	Indoors
Wind:			
Component Temperature:			125 C
Reference Temperature:			70 C
Temperature Rise Above Reference:			55 C
ANSI/IEEE/NEMA Max Allowable Temp @ 100% Load	C

Repair Information		PLEASE FAX BACK AFTER REPAIR		Loss to Production	
Consequences of Failure:		Repair Date:		<input type="checkbox"/> Yes <input type="checkbox"/> No <input checked="" type="checkbox"/> Unknown	
Loss of AGITATOR NO2 LATENCY CHEST B (PEM 877)		Repaired By:			
Parts Req. Before Failure:		Root Cause:			
Parts Req. After Failure:		Repair Procedure:			
Repair Recommendation:		Repair Notes:			
check vibration levels and clean motor and fan to allow cooling
