Infrared Inspection Report

Teva Paper UK Demo

Barrow Plant

Inspection No. 10916

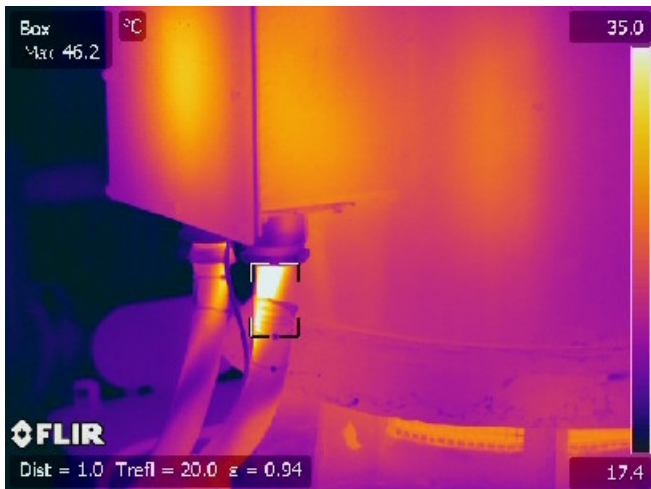
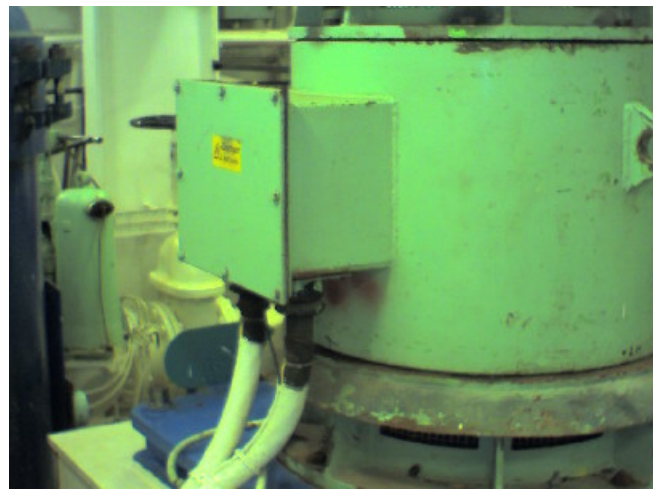
10916-1

Location/Equipment Information	
Asset ID:	
Barcode:	
Location:	MECHANICAL SURVEY PM10 BASEMENT AREA PUMP 1
Component:	Motor
Problem:	incoming phase heating on cable on connection box

Thermal Information	
Operation Priority:	Critical to operation
Repair Priority:	2-Serious
Ambient: 21 C	Environment: Indoors Wind:
Component Temperature On incoming phase	46 C
incoming phase Reference Temperature:	23 C
Temperature Rise Above Reference:	23 C
ANSI/EEE/NEMA Max Allowable Temp @ 100% Load:	C
Est Temp Rise over reference @ 50% Load:	0
Est Temp Rise over reference @ 100% Load:	0

Shut down and inspect connections and cable crimps

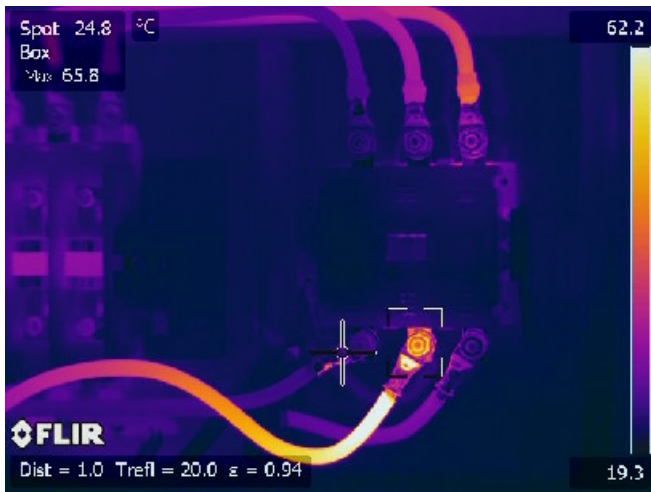
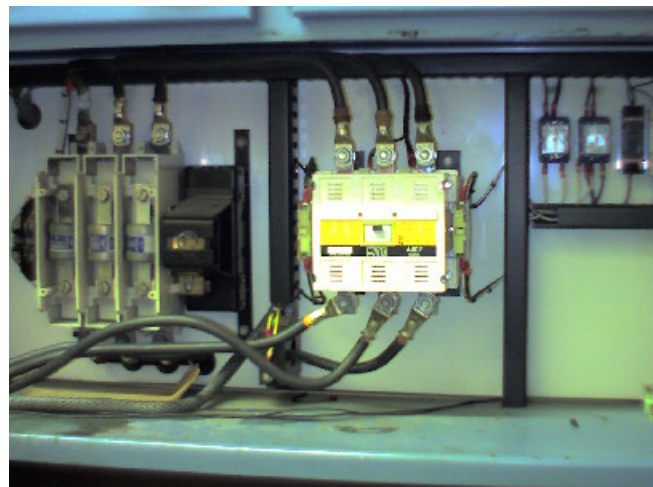
10916-2 Current Prob No: I/C Electrical/2

Location/Equipment Information	
Asset ID:	
Barcode:	
Location:	ELECTRICAL SURVEY PM10 SWITCH ROOM NO2 PNL 204
Component:	contactor
Problem:	yellow phase heating on bottom connection on contactor

Thermal Information	
Operation Priority:	Critical to operation
Repair Priority:	1-Critical
Ambient: 21 C	Environment: Indoors Wind:
Component Temperature On yellow phase:	66 C
red phase Reference Temperature:	25 C
Temperature Rise Above Reference:	41 C
ANSI/EEE/NEMA Max Allowable Temp @ 100% Load:	C
Est Temp Rise over reference @ 50% Load:	0
Est Temp Rise over reference @ 100% Load:	0

PLEASE PROVIDE FEED BACK AFTER REPAIR		Loss to Production
		<input type="checkbox"/> Yes <input checked="" type="checkbox"/> No <input type="checkbox"/> Unknown
Repair Information	Repair Date:	Repaired By:
Consequences of Failure: Loss of PNL 204	Root Cause:	
Parts Req. Before Failure:	Repair Procedure:	
Parts Req. After Failure:	Repair Notes:	
Repair Recommendation: Check the load is balanced and check the connections are clean and tight.

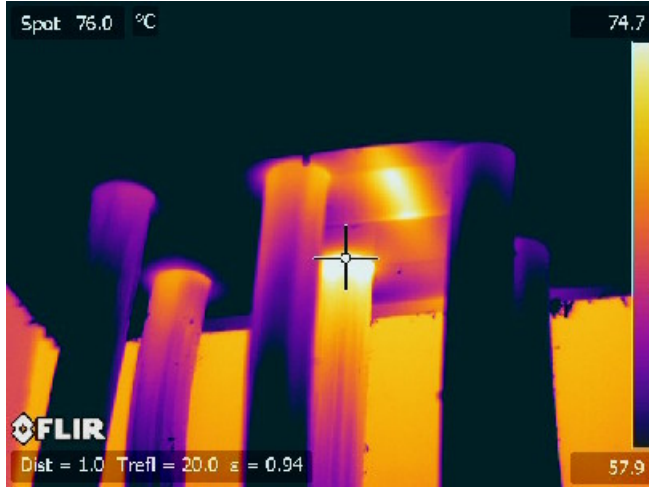
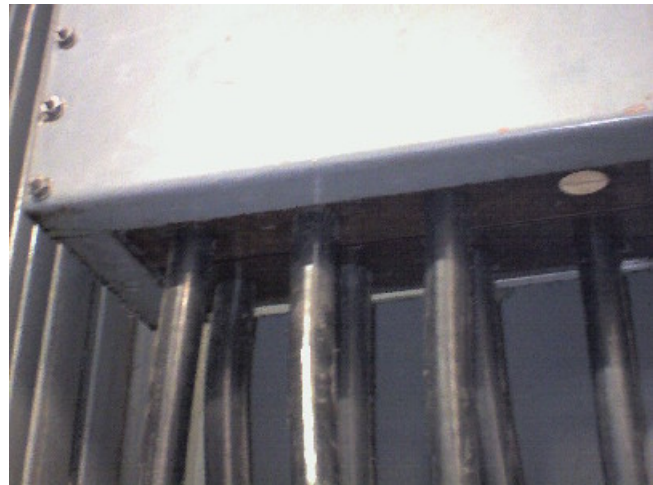
10916-3

Location/Equipment Information	
Asset ID:	
Barcode:	
Location:	ELECTRICAL SURVEY DE-INK SUBSTATION TRANSFORMER N01
Component:	Transformers
Problem:	heating on outgoing cable on Transformer

Thermal Information	
Operation Priority:	Critical to operation
Repair Priority:	2-Serious
Ambient: 18 C	Environment: Indoors Wind:
Component Temperature On outgoing:	76 C
outgoing Reference Temperature:	48 C
Temperature Rise Above Reference:	28 C
ANSI/EEE/NEMA Max Allowable Temp @ 100% Load:	C
Est Temp Rise over reference @ 50% Load:	0
Est Temp Rise over reference @ 100% Load:	0

PLEASE PROVIDE FEED BACK AFTER REPAIR		Loss to Production	
Repair Information Consequences of Failure: Loss of TRANSFORMER N01		<input checked="" type="checkbox"/> Yes <input type="checkbox"/> No <input type="checkbox"/> Unknown	
		Repair Date: <input style="width: 80px;" type="text"/>	Repaired By: <input style="width: 150px;" type="text"/>
Parts Req. Before Failure: <input style="width: 380px;" type="text"/>		Root Cause: <input style="width: 330px;" type="text"/>	
Parts Req. After Failure: <input style="width: 380px;" type="text"/>		Repair Procedure: <input style="width: 330px;" type="text"/>	
Repair Recommendation: Shut down and investigate at earliest opportunity		Repair Notes: <input style="width: 330px;" type="text"/>

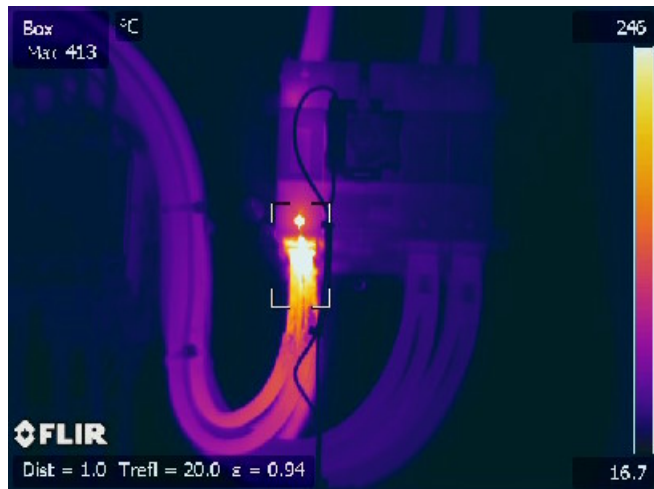
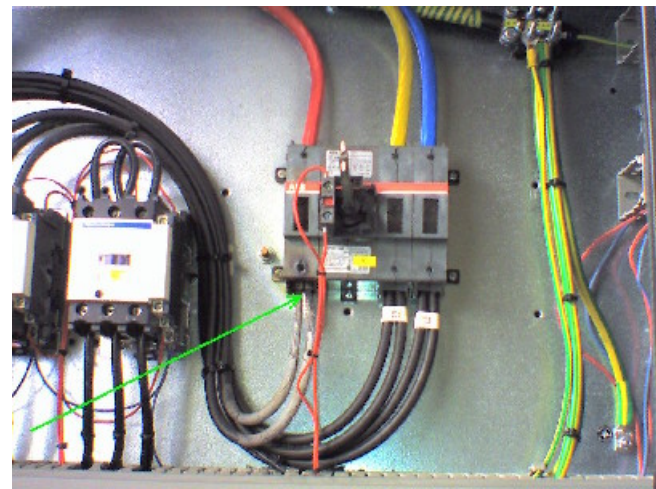
10916-4

Location/Equipment Information	
Asset ID:	
Barcode:	
Location:	ELECTRICAL SURVEY CONVERSION AREA PERINI AREA COMPRESSOR PNL
Component:	Isolator
Problem:	Red phase heating at bottom cable connection on Main Isolator. This cable is showing advanced signs of heat damage and requires immediate attention.

Thermal Information	
Operation Priority:	Critical to operation
Repair Priority:	1-Critical
Ambient: 26 C	Environment: Indoors Wind:
Component Temperature On red phase:	413 C
yellow phase Reference Temperature:	75 C
Temperature Rise Above Reference:	338 C
ANSI/EEE/NEMA Max Allowable Temp @ 100% Load:	C
Est Temp Rise over reference @ 50% Load:	0
Est Temp Rise over reference @ 100% Load:	0

shut down and remake/repair cable

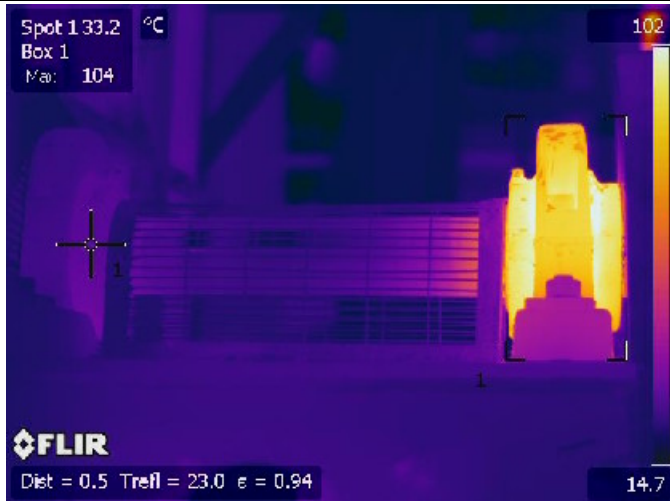
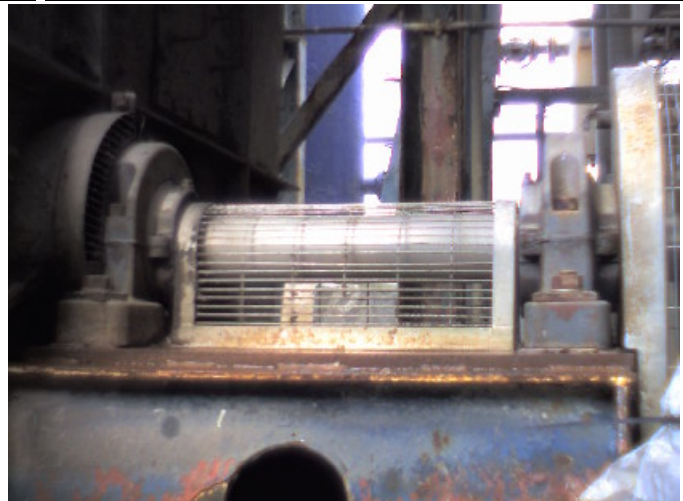
10916-1 Current Prob No: Mechanical/1

Location/Equipment Information		Operation Priority: Critical to operation	
Asset ID: Barcode: Location: MECHANICAL SURVEY BURNER ROOM Z333 DE HOOD RECIRC FAN		Repair Priority: 1-Critical Ambient: 12 C Enviroment: Overcast Wind: 5 Component Temperature: 104 C Reference Temperature: 33 C Temperature Rise Above Reference: 71 C ANSI/EEE/NEMA Max Allowable Temp @ 100% Load: C	
Problem: Increase in temperature on casing on jack-shaft de bearing		ANSI/IEEE/NEMA Max Temp Criteria: Component Type: bearing Manufacturer: Catalog No: Model No: Oil Type: Circuit Voltage: Bearing Type: Component Rated Load: Horse Power (HP) : RPM's:	
Load Test Results			
Rated Load: Component: amps Reference: amps

PLEASE PROVIDE FEED BACK AFTER REPAIR		Loss to Production	
Repair Information		<input checked="" type="checkbox"/> Yes <input type="checkbox"/> No <input type="checkbox"/> Unknown	
Consequences of Failure: Loss of Z333 DE HOOD RECIRC FAN	Repair Date: _____	Repaired By: _____	
Parts Req. Before Failure: _____	Root Cause: _____		
Parts Req. After Failure: _____	Repair Procedure: _____		
Repair Recommendation: Check lubrication schedule .vibration levels and continue to monitor	Repair Notes: _____

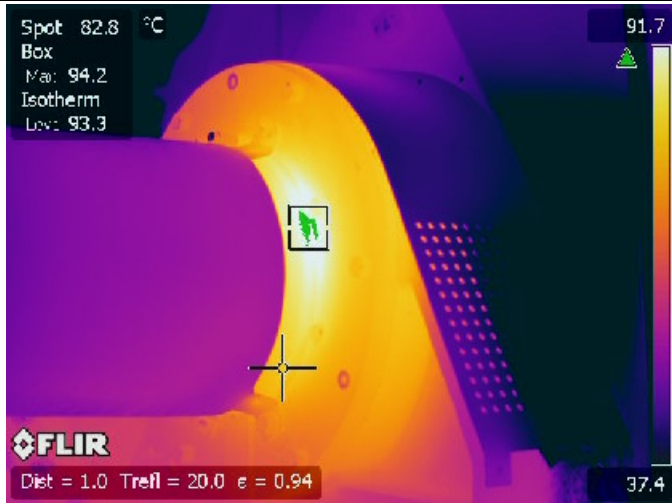
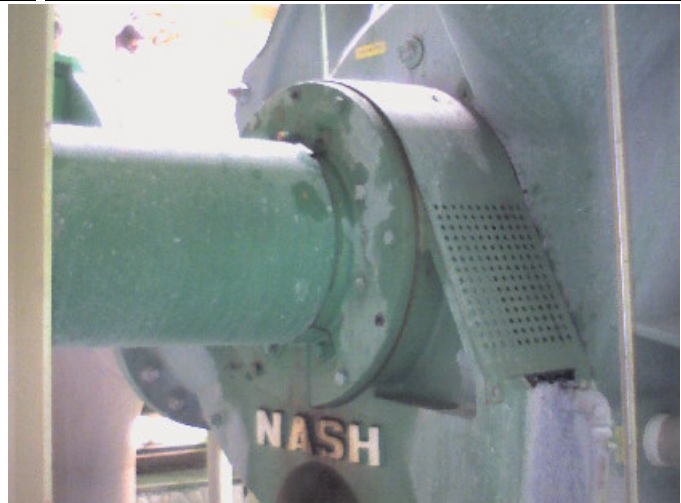
10916-2 Current Prob No: Mechanical/2

Location/Equipment Information		Operation Priority: Critical to operation	
Asset ID:		Repair Priority: 2-Serious	
Barcode:		Ambient: 22 C Enviroment: Indoors	Wind:
Location:	MECHANICAL SURVEY PM10 BASEMENT AREA D227 VACUUM SEAL WATER PUMP	Component Temperature:	94 C
Problem:	high temperature on N D E bearing on vacuum pump. There is a localised high energy area on the casing possibly indicating component wear.	Reference Temperature:	75 C
		Temperature Rise Above Reference:	19 C
		ANSI/EEE/NEMA Max Allowable Temp @ 100% Load:	C
Load Test Results		ANSI/IEEE/NEMA Max Temp Criteria:	
Rated Load:		Component Type: bearing	
Component:	amps	Manufacturer:	
Reference:	amps	Catalog No:	
		Model No:	
		Oil Type:	
		Circuit Voltage:	
		Bearing Type:	
		Component Rated Load:	
		Horse Power (HP) :	
		RPM's:

PLEASE PROVIDE FEED BACK AFTER REPAIR		Loss to Production	
Repair Information		<input checked="" type="checkbox"/> Yes	<input type="checkbox"/> No <input type="checkbox"/> Unknown
Consequences of Failure:	Repair Date:	Repaired By:	
Loss of D227 VACUUM SEAL WATER PUMP			
Parts Req. Before Failure:	Root Cause:		
	Repair Procedure:		
Parts Req. After Failure:	Repair Notes:		
Repair Recommendation:			
Check lubrication schedule .vibration levels and continue to monitor

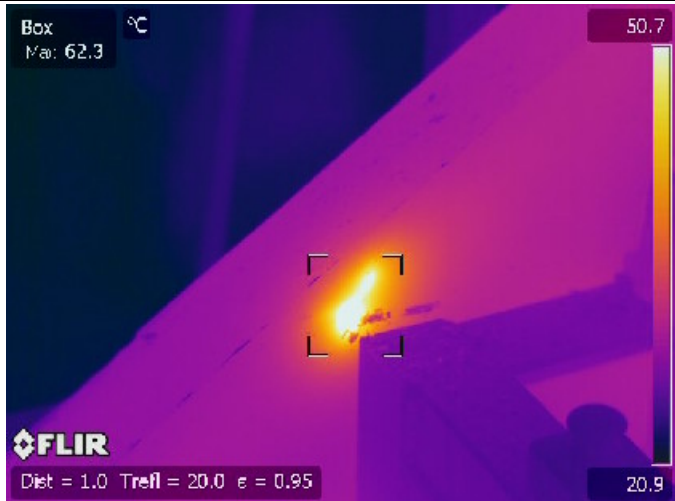
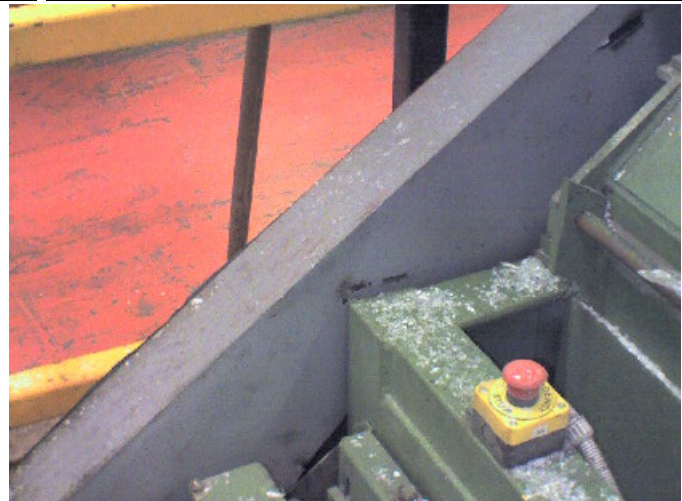
10916-3 Current Prob No: Mechanical/3

Location/Equipment Information		Operation Priority: Critical to operation	
Asset ID: Barcode: Location: MECHANICAL SURVEY PM10 MACHINE HOUSE FLOOR EXHAUST FAN		Repair Priority: 1-Critical	Ambient: 26 C Enviroment: Indoors Wind:
Problem: High temperature through cover on guard		Component Temperature: 62 C	Reference Temperature: 28 C
		Temperature Rise Above Reference: 34 C	ANSI/EEE/NEMA Max Allowable Temp @ 100% Load: C
Load Test Results		ANSI/IEEE/NEMA Max Temp Criteria:	
Rated Load: Component: amps Reference: amps		Component Type: Guard Manufacturer: Catalog No: Model No: Oil Type: Circuit Voltage: Bearing Type: Component Rated Load: Horse Power (HP) : RPM's:

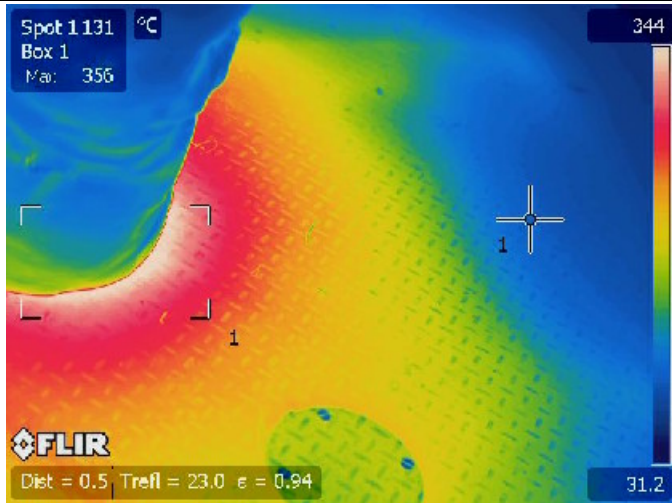
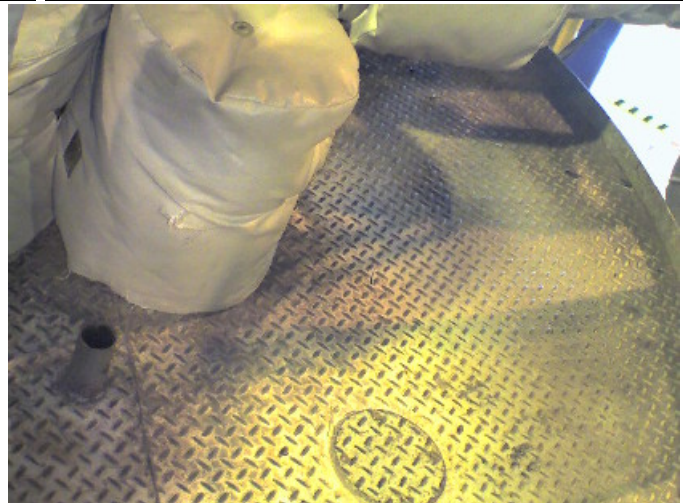
10916-4 Current Prob No: Mechanical/4

Location/Equipment Information		Operation Priority: Critical to operation	
Asset ID:		Repair Priority: 1-Critical	
Barcode:		Ambient: 37 C Enviroment: Indoors Wind:	
Location: MECHANICAL SURVEY BURNER ROOM TURBINE EXHAUST INSULATION		Component Temperature: 356 C	
Problem: High temperature through cover on Exhaust		Reference Temperature: 131 C	
		Temperature Rise Above Reference: 225 C	
		ANSI/EEE/NEMA Max Allowable Temp @ 100% Load: C	
Load Test Results		ANSI/IEEE/NEMA Max Temp Criteria:	
Rated Load:		Component Type: Exhaust	
Component: amps		Manufacturer:	
Reference: amps		Catalog No:	
		Model No:	
		Oil Type:	
		Circuit Voltage:	
		Bearing Type:	
		Component Rated Load:	
		Horse Power (HP) :	
		RPM's:

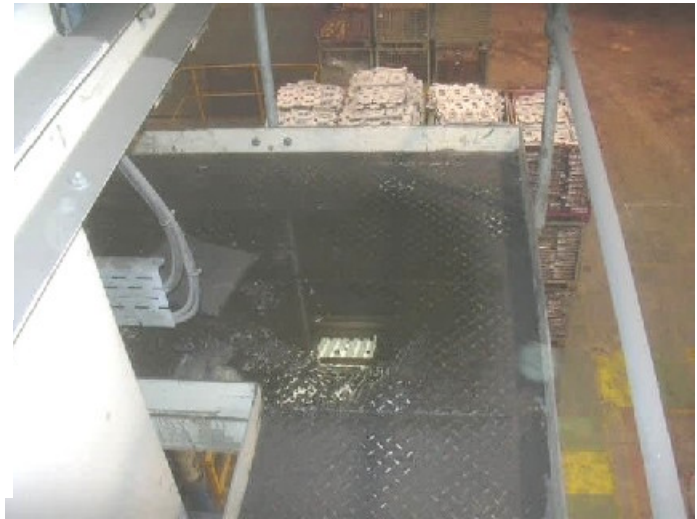
10916-1

Location/Equipment Information	
Asset ID:	
Barcode:	
Location:	MECHANICAL SURVEY 1ST FLOOR CONVEYORS CONVEYOR NO1

Operation Priority:	Critical to operation
Repair Priority:	2-Serious
Hazard Type:	DANDEROUS AREA
Hazard Classification:	Injury to personel
Hazard Group:	slips .trips and falls
Hazard Issue:	oil leak under gearbox/motor area on platform
Observations:	slips .trips and falls, oil leak under gearbox/motor area on platform
What is the Cause:	oil leakage from gearbox / motor area

PLEASE PROVIDE FEED BAACK		Loss to Production	
Repair Information		<input type="checkbox"/> Yes	<input checked="" type="checkbox"/> No
		<input type="checkbox"/> Unknown	
Consequences of Failure:	Repair Date:	Repaired By:	
<input type="text"/>	<input type="text"/>	<input type="text"/>	
Parts Req. Before Failure:	Root Cause:	<input type="text"/>	
<input type="text"/>	Repair Procedure:	check gearbox for correct oil level locate leaking area and clean up	
Parts Req. After Failure:	Repair Notes:	<input type="text"/>	
<input type="text"/>			
Repair Recommendation:			
check gearbox for correct oil level locate leaking area and clean up
