# Air Leak Detection Report

## **TEVA LTD Demo**

### **Barrow Site**

Inspection No. 10915

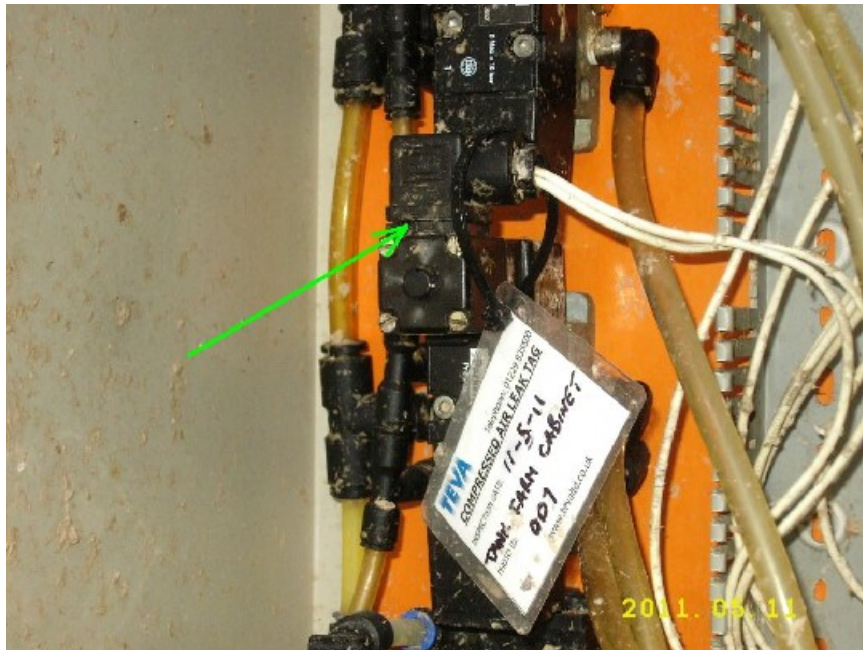
10915-1

Location/Equipment Information	
Asset ID:	
Barcode:	
Location:	TEVA LTD BARROW TANK FARM MAIN SUPPLY CAB

Operation Priority:	Critical to operation
Repair Priority:	3-Important
Hazard Type:	Air Leak
Hazard Classification:	Energy Loss
Hazard Group:	Air Leak
Hazard Issue:	solenoid block leaking
Observations:	Air Leak - Compressed Air Leak on solenoid block (5.7)
What is the Cause:	air leak

Repair air leak if possible. If not replace item

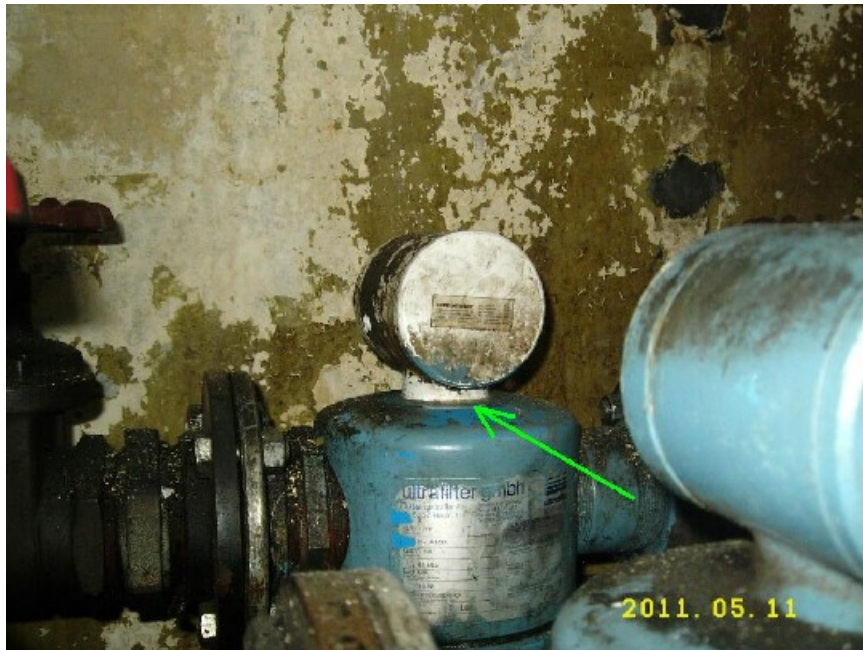
10915-2

Location/Equipment Information	
Asset ID:	
Barcode:	
Location:	TEVA LTD BARROW COMPRESSOR HOUSE FILTER UNIT 1

Operation Priority:	Critical to operation
Repair Priority:	3-Important
Hazard Type:	Air Leak
Hazard Classification:	Energy Loss
Hazard Group:	Air Leak
Hazard Issue:	air leak of top of filter
Observations:	Air Leak - Compressed Air Leak on top of filter around guage connection (6.2)
What is the Cause:	air leak

Make seal good around guage

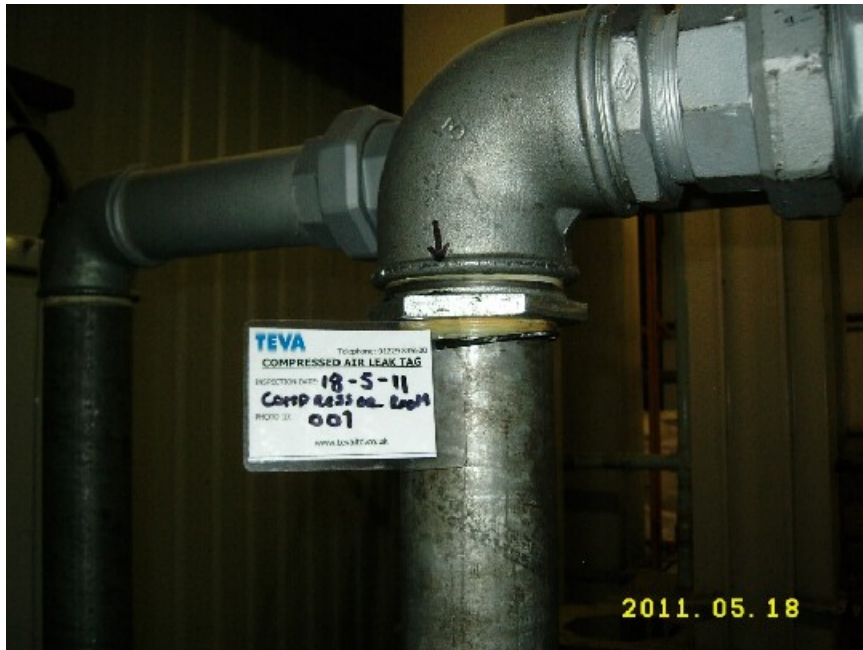
10915-3

Location/Equipment Information	
Asset ID:	
Barcode:	
Location:	TEVA LTD BARROW COMPRESSOR HOUSE COMPRESSOR 1

Operation Priority:	Critical to operation
Repair Priority:	3-Important
Hazard Type:	Air Leak
Hazard Classification:	Energy Loss
Hazard Group:	Air Leak
Hazard Issue:	on pipework
Observations:	Air Leak - Compressed Air Leak on pipework from compressor 1 (6.0)
What is the Cause:	air leak on pipework

Re-seal and make joint good

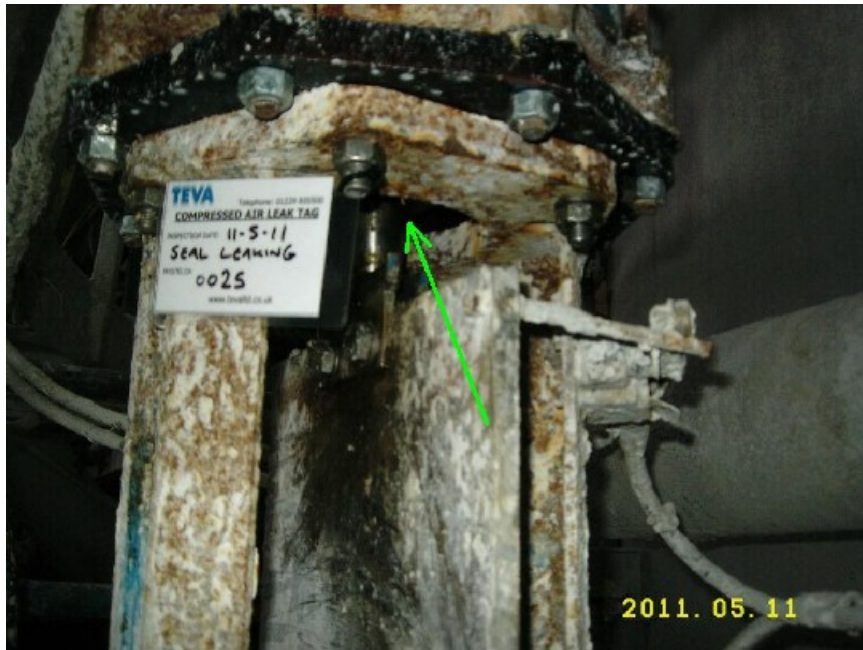
10915-4

Location/Equipment Information	
Asset ID:	
Barcode:	
Location:	TEVA LTD BARROW DE-INK AREA CELL 2

Operation Priority:	Critical to operation
Repair Priority:	3-Important
Hazard Type:	Air Leak
Hazard Classification:	Energy Loss
Hazard Group:	Air Leak
Hazard Issue:	on open/ close control valve
Observations:	Air Leak - Compressed Air Leak on pnumatic control valve (5.2)
What is the Cause:	Wear and/ or damage to seals

Shut down and check seals for damage. Replace if necessary

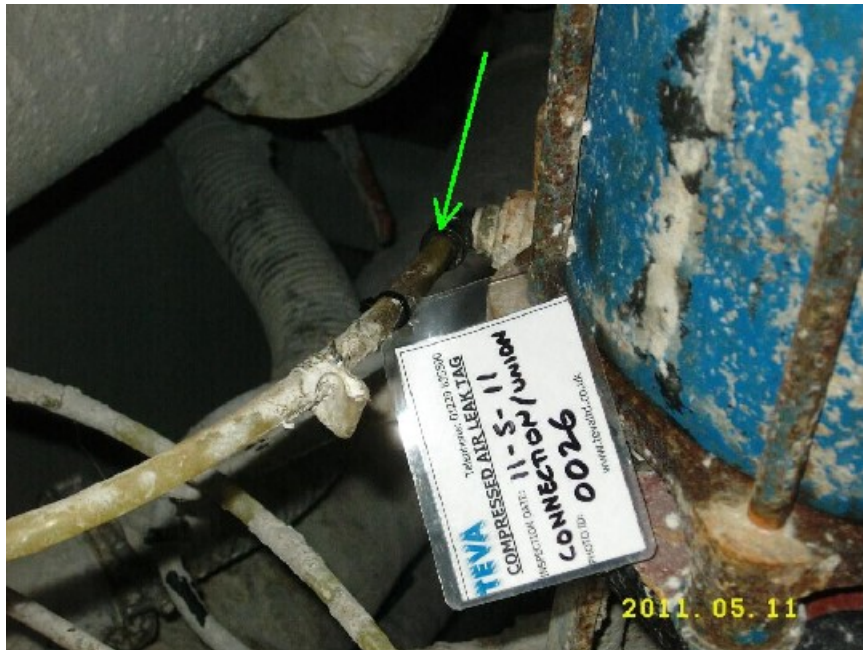
10915-5

Location/Equipment Information	
Asset ID:	
Barcode:	
Location:	TEVA LTD BARROW BASEMENT SILO 2

Operation Priority:	Critical to operation
Repair Priority:	3-Important
Hazard Type:	Air Leak
Hazard Classification:	Energy Loss
Hazard Group:	Air Leak
Hazard Issue:	on union
Observations:	Air Leak - Compressed Air Leak on union to silo 2 pneumatic control unit (6.3)
What is the Cause:	air leak

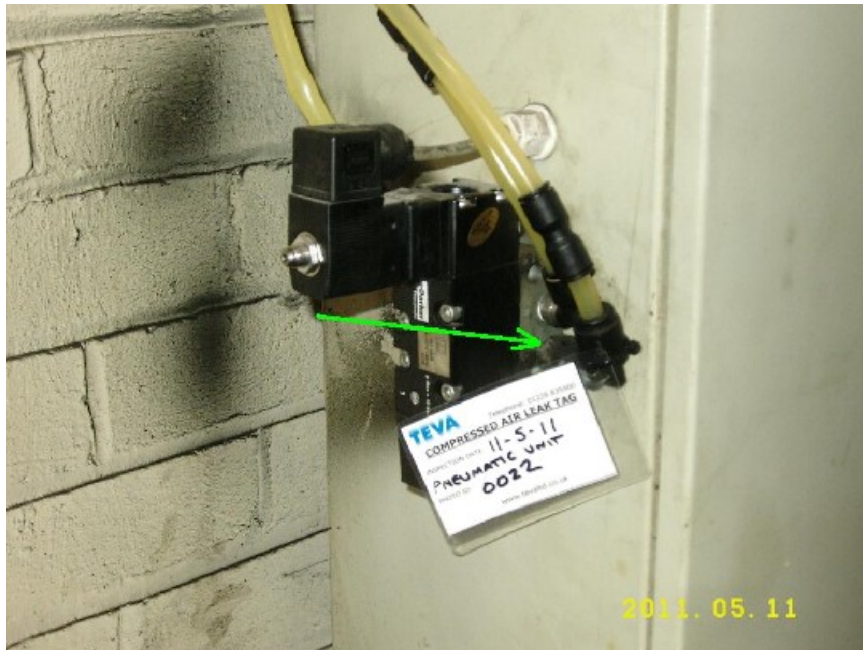
10915-6

Location/Equipment Information	
Asset ID:	
Barcode:	
Location:	TEVA LTD BARROW MACHINE HOUSE PM1 AREA CALENDAR ROLL CONTROL CAB

Operation Priority:	Critical to operation
Repair Priority:	3-Important
Hazard Type:	Air Leak
Hazard Classification:	Energy Loss
Hazard Group:	Air Leak
Hazard Issue:	air leak on connection to solenoid valve
Observations:	Air Leak - Compressed Air Leak on connection to solenoid valve (5.2)
What is the Cause:	air leak

Repair air leak if possible. If not replace item

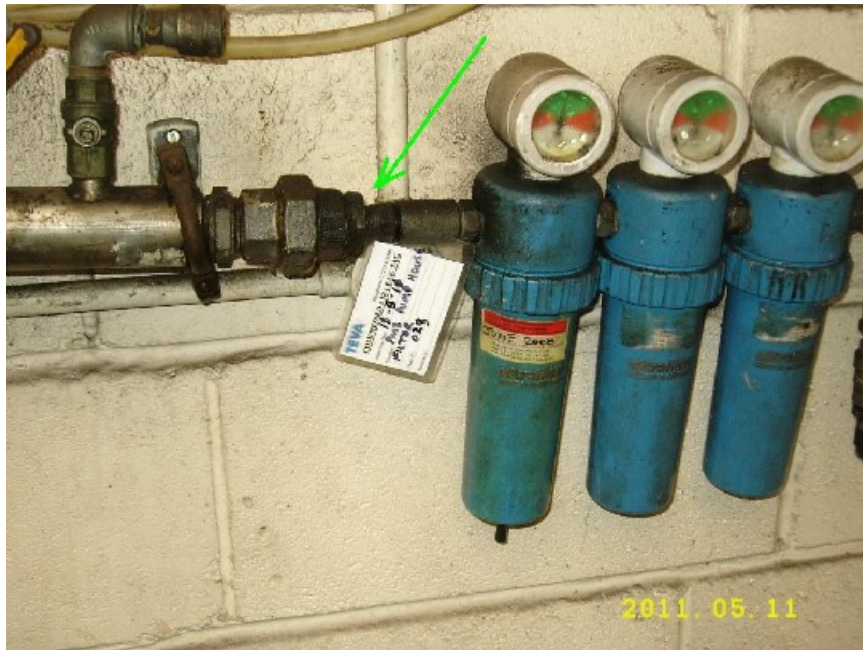
10915-7

Location/Equipment Information	
Asset ID:	
Barcode:	
Location:	TEVA LTD BARROW MACHINE HOUSE PM2 AREA PM2 PUMP HOUSE FILTER UNIT

Operation Priority:	Critical to operation
Repair Priority:	3-Important
Hazard Type:	Air Leak
Hazard Classification:	Energy Loss
Hazard Group:	Air Leak
Hazard Issue:	on pipework to filter
Observations:	Air Leak - Compressed Air Leak on pipework to filter unit (6.3)
What is the Cause:	air leak

Make pipework seal good

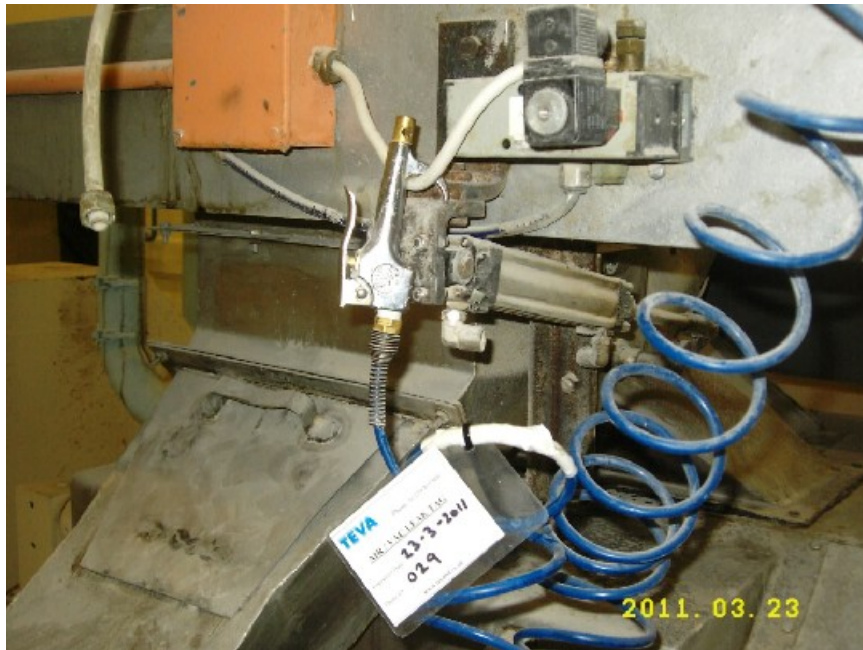
10915-8

Location/Equipment Information	
Asset ID:	
Barcode:	
Location:	TEVA LTD BARROW MACHINE HOUSE PM1 AREA PM1 WINDER

Operation Priority:	Critical to operation
Repair Priority:	3-Important
Hazard Type:	Air Leak
Hazard Classification:	Energy Loss
Hazard Group:	Air Leak
Hazard Issue:	on air gun flex
Observations:	Air Leak - Compressed Air Leak on air gun flex (5.3)
What is the Cause:	Damaged air line

Cut back. Re-fix air gun ensuring connection is sealed and tight.

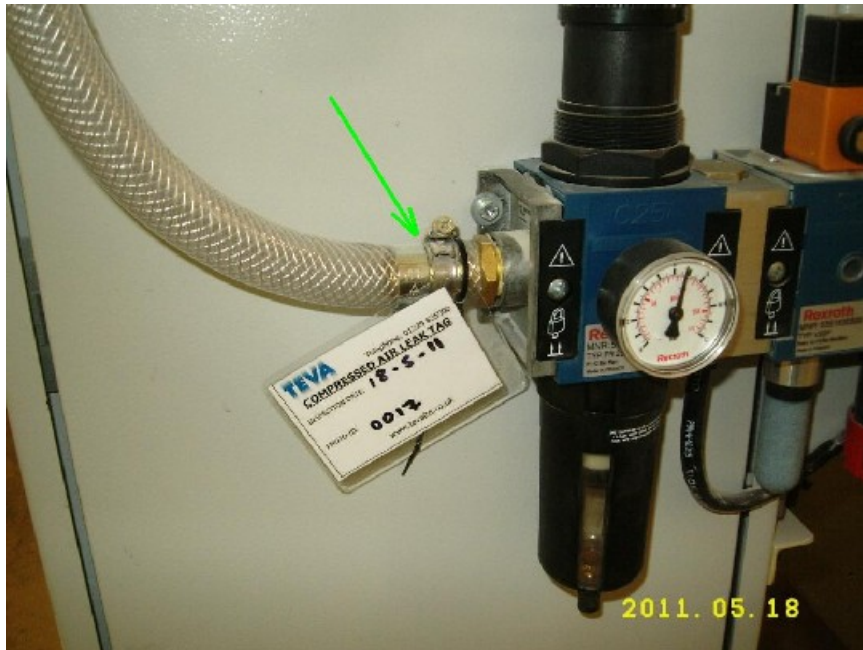
10915-9

Location/Equipment Information	
Asset ID:	
Barcode:	
Location:	TEVA LTD BARROW BASEMENT PM1 SEC 2 F/S

Operation Priority:	Critical to operation
Repair Priority:	3-Important
Hazard Type:	Air Leak
Hazard Classification:	Energy Loss
Hazard Group:	Air Leak
Hazard Issue:	on filter connection
Observations:	Air Leak - Compressed Air Leak on filter connection (4.6)
What is the Cause:	Loose/ Bad connection

Re-seal and tighten connection

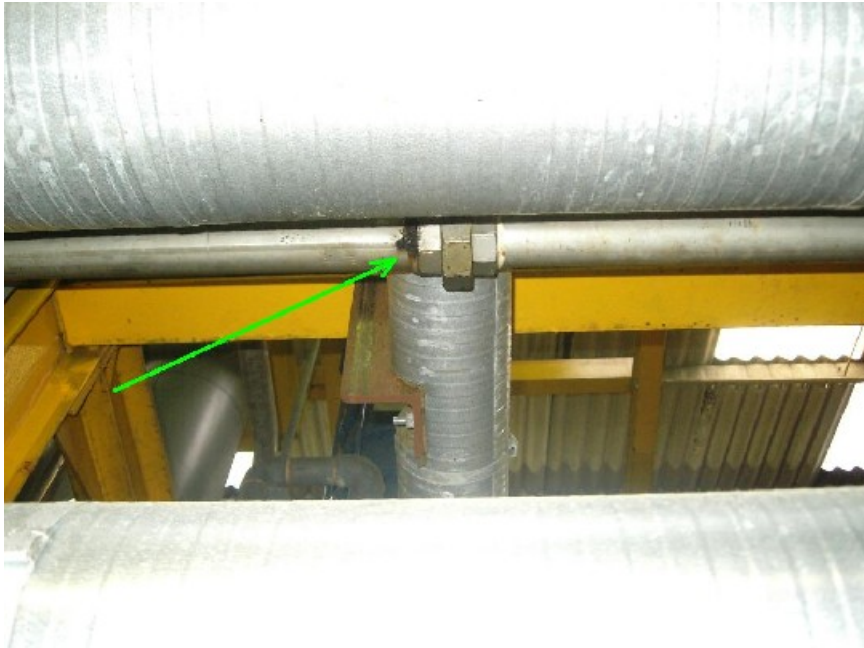
10915-10

Location/Equipment Information	
Asset ID:	
Barcode:	
Location:	TEVA LTD BARROW REFINER ROOM MAIN PIPEWORK RING MAIN

Operation Priority:	Critical to operation
Repair Priority:	3-Important
Hazard Type:	Air Leak
Hazard Classification:	Energy Loss
Hazard Group:	Air Leak
Hazard Issue:	on pipework
Observations:	Air Leak - Compressed Air Leak on pipework connection above 'D' Refiner (6.8)
What is the Cause:	air leak on pipework

Re-seal and make joint good
